报告编号	结论	报告日期	图片	备注
DAJC-7F10294-2022	合格	2022-06-23

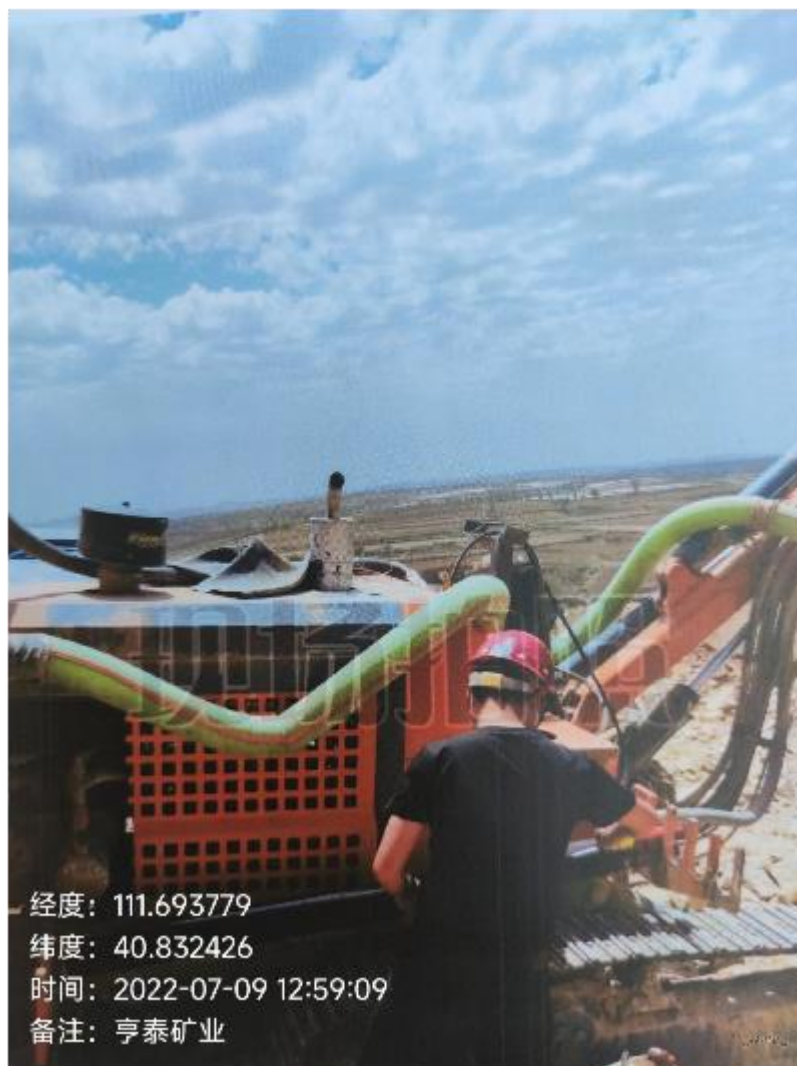
DAJC-7F49009-2022

合格

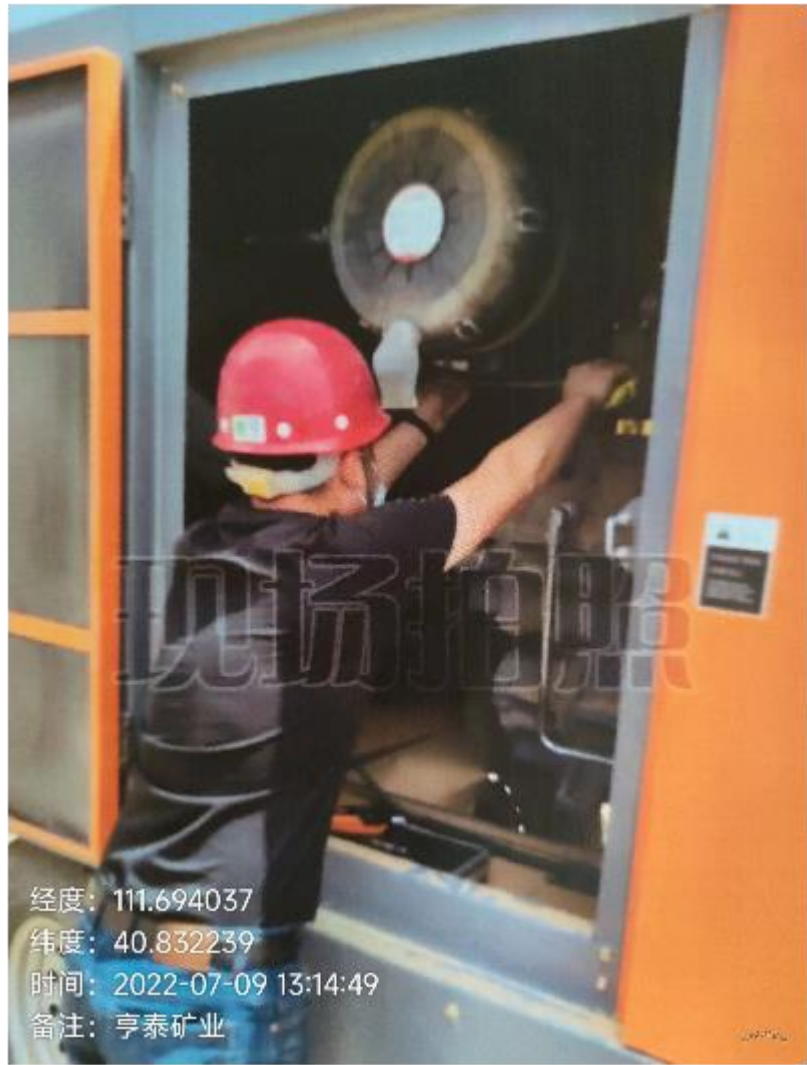
DAJC-7F50042-2022

合格

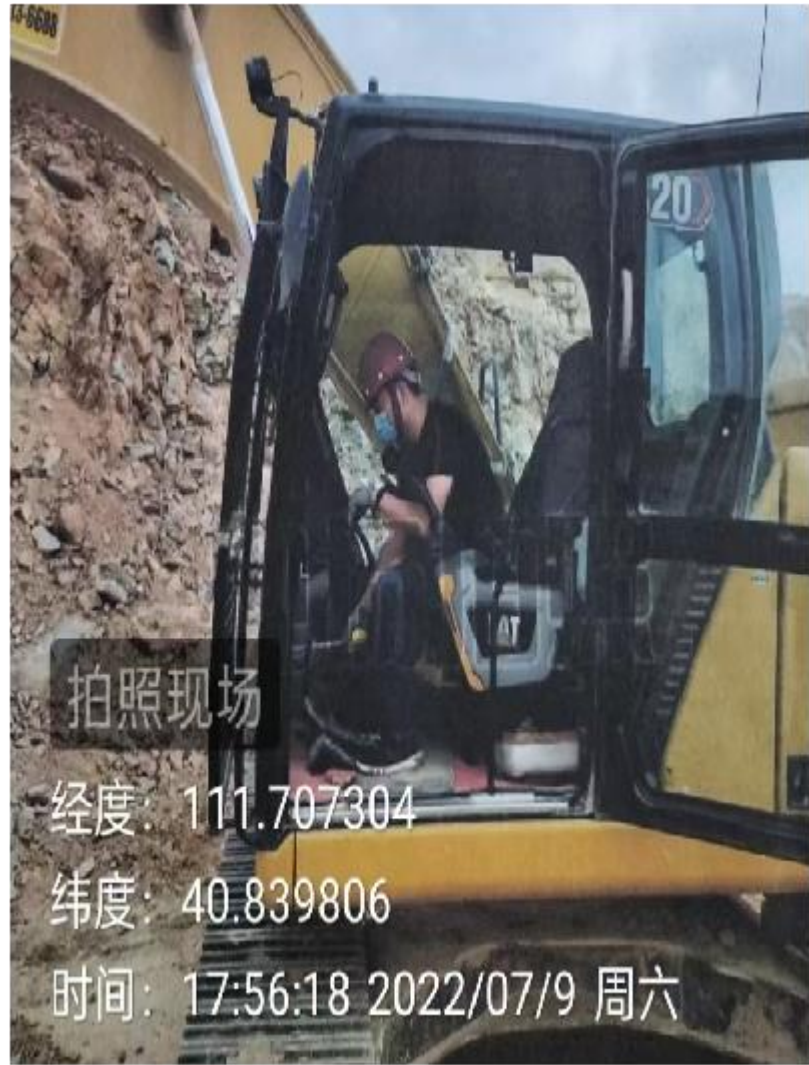
DAJC-7F88014-2022

合格

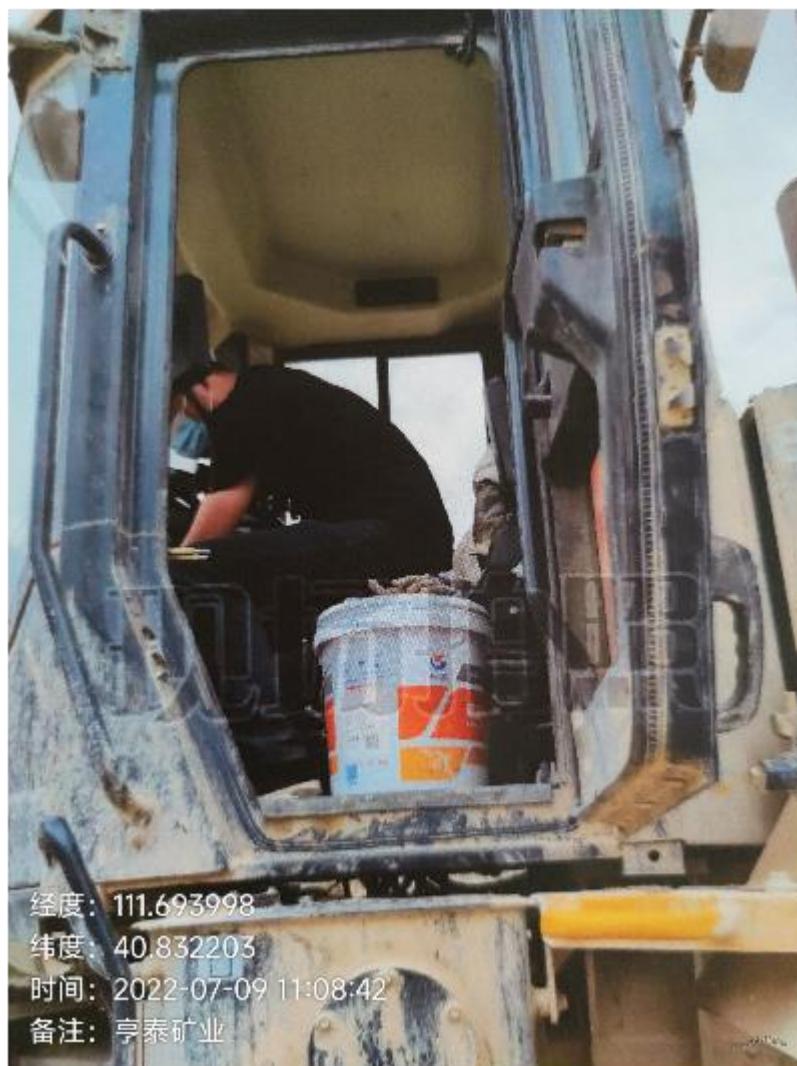
DAJC-7F89053-2022

合格

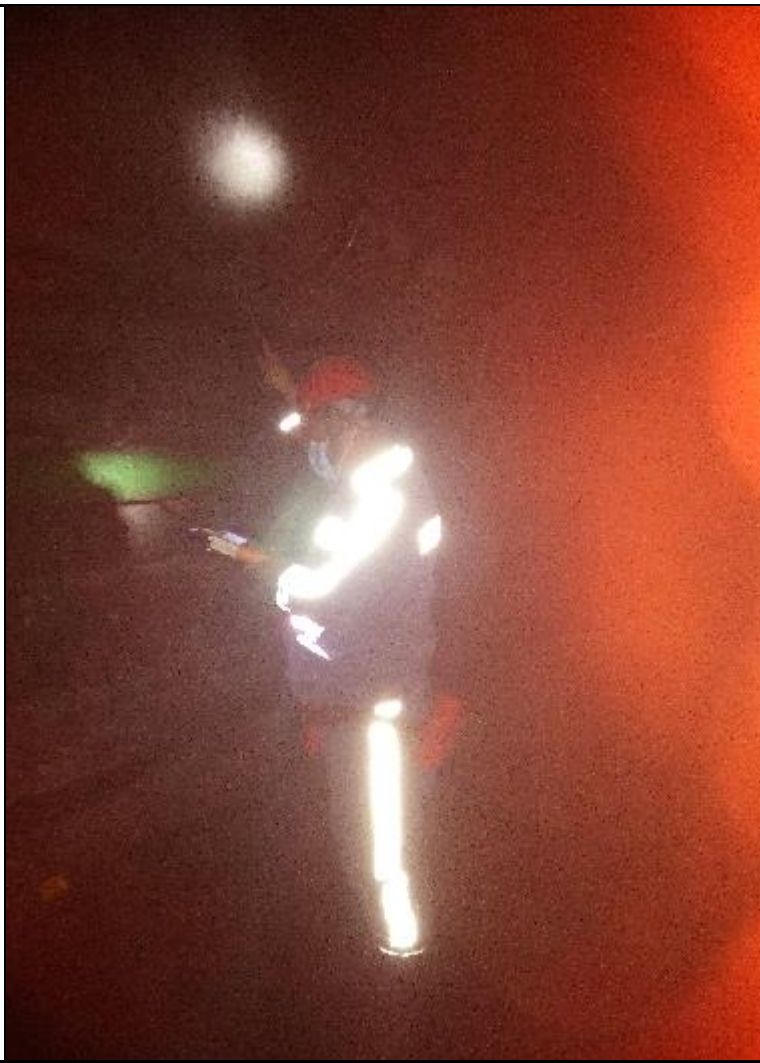
DAJC-128013-2022

合格

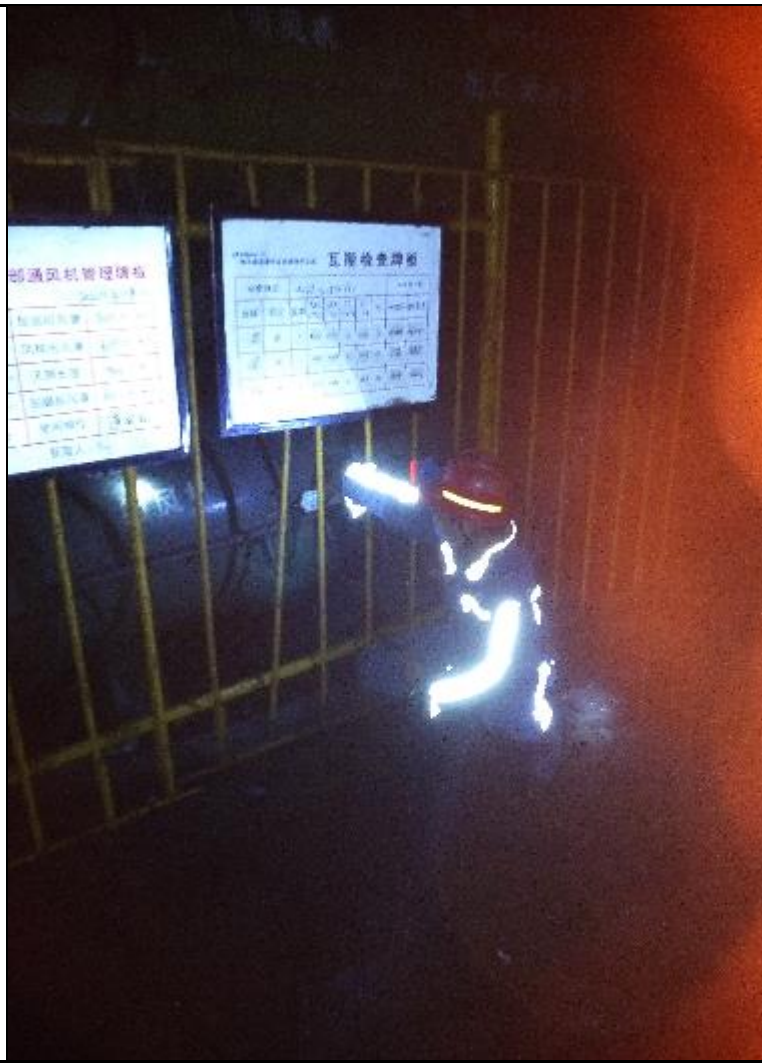
DAJC-128014-2022

合格
